BASELINE RBMP ASSESSMENT

Kintore Flood Study

Project no. 4021839

Aberdeenshire Council

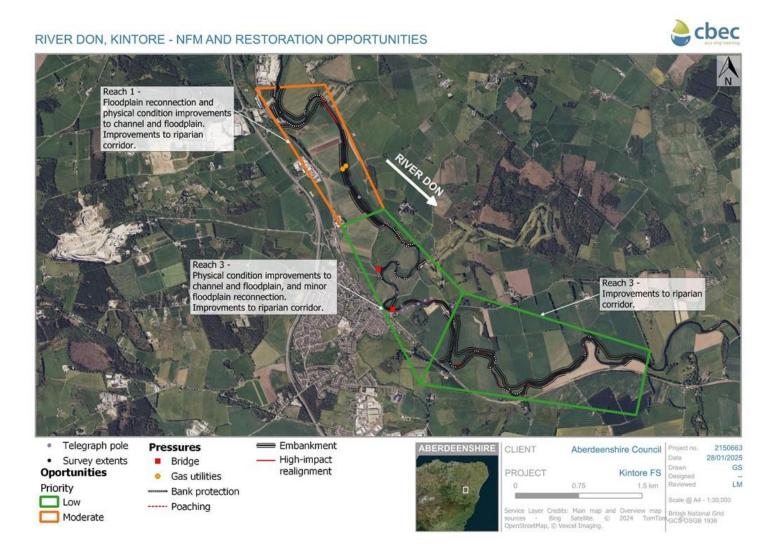
Figure 2-1 - Overview of pressures and potential options to improve RBMP status: River Don, Kintore.

acbec RIVER DON, KINTORE REACH 1 - NFM AND RESTORATION OPPORTUNITIES Physical condition -Planting of riparian corridor on river left and right banks to improve Improve connection to floodplain areas by setting back or breaching river right embankments. Physical condition -Enhance floodplain diversity by constructing scrape/swale features. **Key constraints:** Gas utilities **Pressures** ABERDEENSHIRE CLIENT Aberdeenshire Council Project no. Telegraph pole High value agricultural land. 12/11/2024 Bank protection GS **Oportunities** Fishing beat. **PROJECT** Kintore FS ---- Poaching Fishing hut and access track. 100 200 300 400 m Priority === Embankment Waste water treatment works. Low — High-impact Gas utilities. Service Layer Credits: SEPA and Scottish Water (2012). LiDAR for Scotland Phase 1 DTM_ 1m. Bing Satellite. © 2024 TomTom, © OpenStreetMap, © Vexcel Imaging. Moderate realignment Telegraph poles.

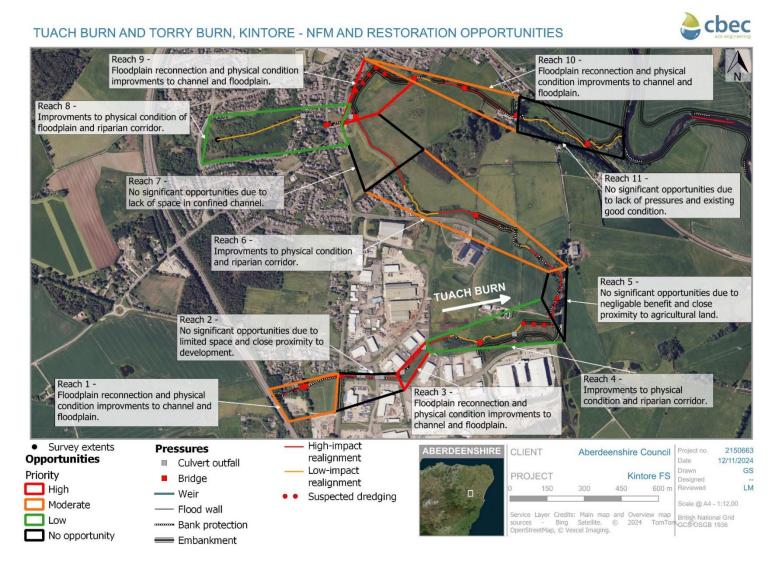
Figure 2-4 - Overview of pressures and potential options to improve RBMP status: Tuach Burn and Torry Burn, Kintore.

TUACH BURN REACH 1 TO 3 - NFM AND RESTORATION OPPORTUNITIES Physical condition -Planting of riparian corridor on river right bank or along restored sinuous channel. NFM -Reconnect river right floodplain by restoring a sinuous channel. Reconnect river right floodplain by removing embankment and Physical condition -Removal of embankment and bank restoring a sinuous channel. TAUCH BURN protection pressures on river left. Complimentary to NFM measures. Physical condition removal of weir and river right bank protection pressures. Complimentary to NFM measures. Physical condition -Physical condition -Enhance floodplain habitat by Planting of riparian corridor on river constructing scrape/swale left and right banks. features. Physical condition -Restore floodplain habitat by constructing scrape/swale features. Telegraph Pole Pressures Flood wall ABERDEENSHIRE CLIENT Aberdeenshire Council 2150663 **Key constraints:** Watercourse Weir Bridge 12/11/2024 Opportunities GS Possible contaminated land - Bank protection Culvert outfall Kintore FS Existing amenities Priority High-impact 75 100 m == Embankment 50 High Residential properties realignment Scale @ A4 - 1:3,600 Critical roads and bridges ervice Layer Credits: SEPA and Scottish Water Moderate Low-impact (2012). LiDAR for Scotland Phase 1 DTM_ 1m. British National Grid Bing Satellite. © 2024 TomTon, GCS @SGB 1936 Critical culvert outfalls realignment Low Telegraph poles nStreetMap, © Vexcel Imaging. No opportunity

Reach Number	Priority	Geomorphic characteristics and pressures	Options	Constraints	Multiple benefits
1	Moderate Scope for NFM and physical improvement. Constraints present. See Figure 2.5	 Unconfined valley setting. Mostly straight channel with simplified morphology. Somewhat connected to floodplain. A tributary channel joins the channel from river right. Significant pressures are: high-impact realignment, land-raising embankments, bank protection and flood walls. 	 Potential to reconnect the floodplain along the river right, utilising the area of derelict land and playing field. Restoration of floodplain habitat by installing scrapes and swales. Removal of bank protection and land-raising embankment pressures to increase floodplain connectivity and improve physical condition. Potential to restore sinuosity through assisted recovery techniques. Potential to enhance the riparian corridor. 	measures are in place to protect residential properties on river left bank.	 Increased floodplain connectivity. Enhanced river and floodplain habitat by improving physical condition Community benefits by providing engagement with nature.

Reach Number	Priority	Geomorphic characteristics and pressures	Options	Constraints	Multiple benefits
3 imp	High Scope for NFM and physical provement. e Figure 2.5	 Partially confined valley setting. Straight channel with homogeneous character. Floodplain area located to the river right, but connectivity is restricted because the channel is incised. Key pressures are: high-impact realignment, bank protection and a lack of riparian vegetation. There are also two culvert outfalls and a weir. Note, whilst only discrete sections of bank protection were observed along this reach, it is suspected that it is continuous but was concealed under high flows. 	 Potential to reconnect the floodplain to the river right. Potential to restore floodplain wetland habitat by installing scrapes and swales. Potential to remove bank protection and weir pressures to improve physical condition. Potential to increase sinuosity, utilising river left floodplain space. Establish a riparian corridor to improve physical condition. 	 The pipe culvert outfalls may need to remain functional. Industrial buildings in close proximity to the river left bank. 	 Increasing sinuosity and channel roughness aids floodplain connectivity and slows the flow. Benefits channel and floodplain habitat. Riparian vegetation provides roughness, which attenuates flood flows, and benefits inchannel species by providing cover and nutrients.

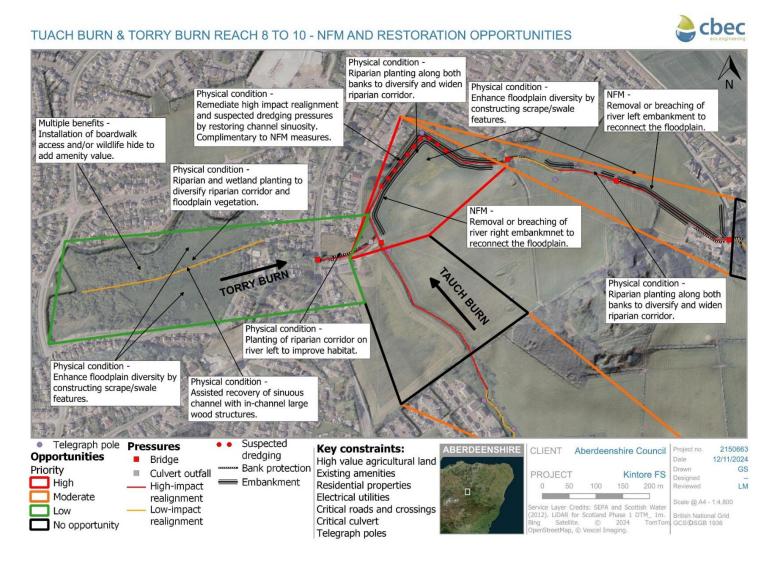
Figure 2-7 - Opportunities, pressures and constraints along reaches 8 to 10: Tuach Burn and Torry Burn, Kintore.

Reach Number	Priority	Geomorphic characteristics and pressures	Options	Constraints	Multiple benefits
8	Low Scope for physical improvements. Existing connected floodplain. See Figure 2.7	 Unconfined valley setting. Channel is straight, though poorly defined through a well-connected floodplain, hosting wetland vegetation. Floodplain vegetation is dense but homogeneous. A wet woodland is present on the river left floodplain towards the upstream extent of the reach. Towards the downstream extent, the channel is straight with limited floodplain space and a homogeneous character. Significant pressures include: high-impact realignment and bank protection located towards the downstream extent of the reach. There is also a bridge, a culvert and bank protection. Low-impact realignment and underdeveloped riparian vegetation was identified in the vicinity of Torryburn Wood. 	 Potential to recover sinuosity by installing in-channel large wood structures along the upstream section near Torryburn wood. Potential to enhance floodplain habitat by diversifying vegetation and installing large wood structures. Scrapes and/or swales could be installed more broadly across the floodplain to increase topographic variability. Boardwalk access and/or a wildlife hide could be installed to add amenity value for the local community. Potential to establish a riparian corridor towards the downstream extent of the reach. 	 A bridge supports a road crossing. A culvert supports an access track to residential properties. Bank protection supporting electrical utilities located close to the river right bank. 	 Community benefit by facilitating engagement with floodplain wetland and river habitats. Benefit to wildlife by enhancing habitat.

Reach Number	Priority	Geomorphic characteristics and pressures	Options	Constraints	Multiple benefits
9	High Scope for NFM and physical improvements. See Figure 2.7	 Unconfined valley setting. Mostly straight channel with homogeneous character. Riparian vegetation is continuous but simple (lacking trees). Significant pressures are: high- impact realignment and embankments. There is also a footbridge and sections where dredging activity is suspected. 	 Potential to remove or breach river right embankment to improve floodplain connectivity. Total removal or setting back of river right embankment would create space to restore a sinuous planform and improve the physical condition. Potential to enhance floodplain habitat by installing wetland scrapes/swales. Diversify and widen riparian corridor. 		 Community benefit by enhancing existing recreational area. Flood risk benefit by reconnecting the floodplain and increasing roughness. Improvements to channel and floodplain wetland habitat. Riparian vegetation aids bank stability.

Reach Number	Priority	Geomorphic characteristics and pressures	Options	Constraints	Multiple benefits
10	Moderate Scope for NFM and physical improvements. See Figure 2.7	 Partially confined valley setting, confined by steep slopes grading down to the channel on river right. Mostly straight channel, homogeneous in character. Significant pressures are: high-impact realignment, embankments and a lack of riparian vegetation. There are also two bridges, located at the upstream extent and in the middle of the study site. 	river left embankments to	 Bridge located in the middle of the reach. Bank protection/flood wall protecting buildings on the river right. Downstream embankment supporting a road. Potential constraint if floodplain land use is agricultural. 	channel sinuosity and roughness. Improvements to channel and floodplain wetland habitat.
11	No Opportunities	Unconfined valley setting. Sinuous channel with diverse morphology and mature riparian corridor. The channel is impacted by few pressures, comprising an embankment on the river left at the downstream extent and a culvert that supports a rail crossing. No opportunities are highlighted here as measures will likely be destructive to existing good conditions for a negligible increase in floodplain connectivity and physical condition.
